Manhole Inspection Summary

Manhole # S25MM_022MH

Insp Date: **7/27/07 10:12 AM**

Location Address: **2401 LINDEN AVE**

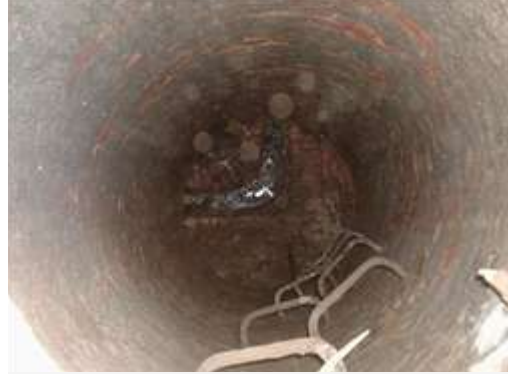
Top View

Corroded and missing steps. Bench and Channel debris.

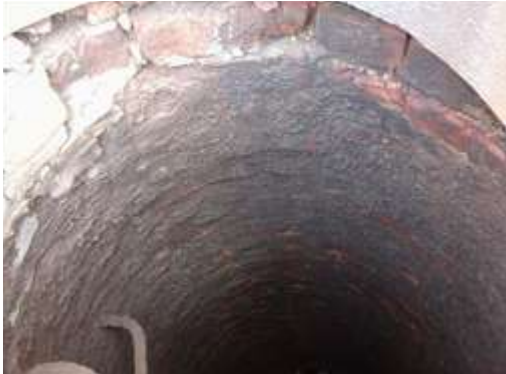
Defect

Frame leaks. Frame offset. Adjustment deterioration, loose brick and infiltration. Corbel and Barrel infiltration - other side.

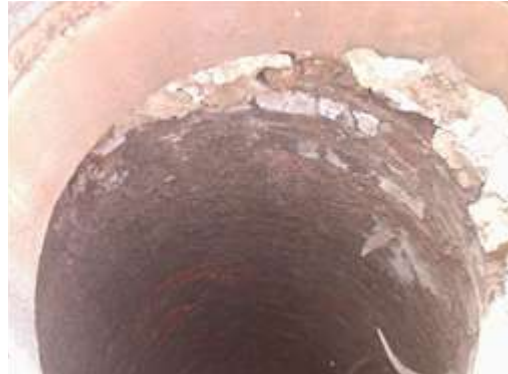
Defect

Frame leaks. Frame offset. Adjustment deterioration, loose brick and infiltration. Corbel and Barrel infiltration.

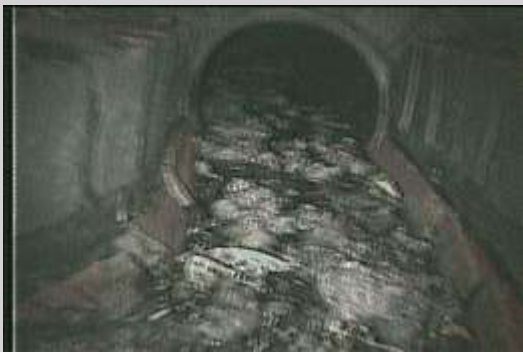
8 in. Circular Gravity Sewer Pipe Out @ 12 O'Clock

Deposits: ☐ None ☒ **Mud** ☐ Sludge ☒ **Debris** ☒ **Grease**

Silt Depth: **2** (in.) Deposits Extent: **Light**

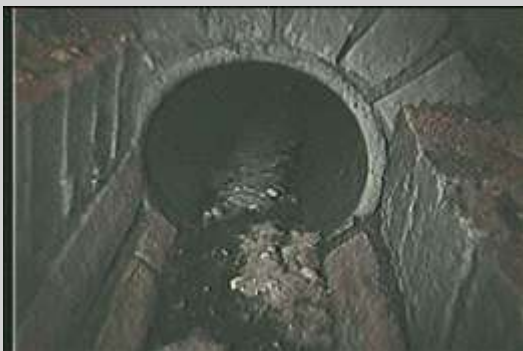
8 in. Circular Gravity Sewer Pipe In @ 9 O'Clock

Deposits: ☐ None ☒ **Mud** ☐ Sludge ☒ **Debris** ☐ Grease

Silt Depth: **0.5** (in.) Deposits Extent: **Light**
